The Road Infrastructure Damage Assessment in East Penfui Village, Kupang District

ABSTRACT

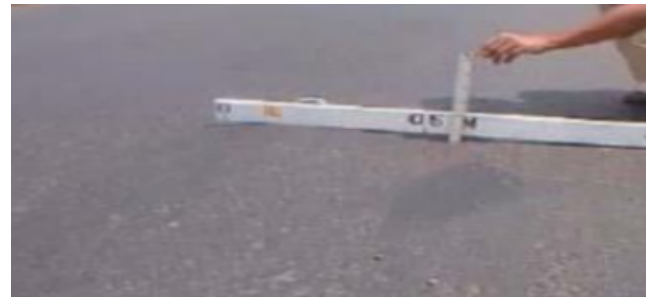
Figure 4. Example of Distortion (ruts)
(Direktorat Jendral Bina Marga, 1983)

Distortion is a change in shape that can occur due to weak subgrade and a lack of compaction in the foundation layer. Distortion can be distinguished by ruts, corrugation, shoving, grade depressions, and upheaval.

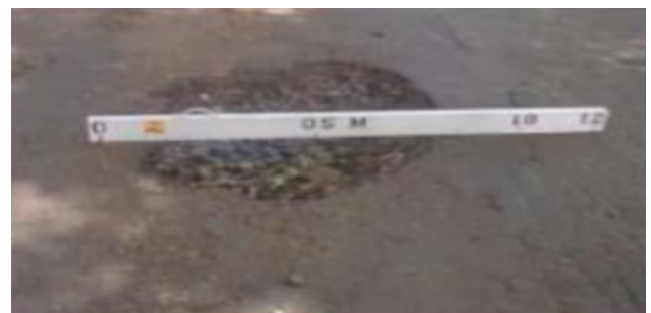
Figure 5. Example of Disintegration (Pothole)
(Direktorat Jendral Bina Marga, 1983)

Surface defects are a type of damage that leads to chemical and mechanical damage to the pavement. Surface defects include potholes, reveling, and stripping of the surface layer. Repairs can be made by removing the old layer and filling it with new pavement mix.

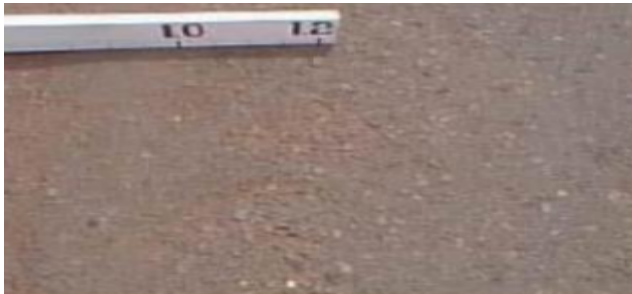
Figure 6. Example of Polished Aggregates
(Direktorat Jendral Bina Marga, 1983)

Polish aggregates are damaged with their surface characteristics becoming smooth due to the use of round and smooth aggregates, not cubical-shaped. Repairs can be made by closing the layer using thin layer of asphalt sand or asphalt paving.

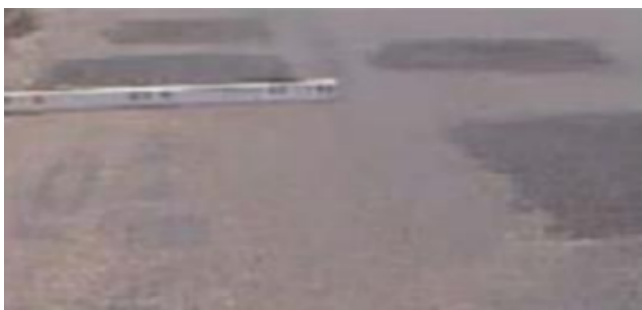
Figure 8. Example of Utility Cut Depression
(Direktorat Jendral Bina Marga, 1983)

Occurs due to compaction that does not meet the requirements in closing former utility plantings. Repairs can be made by disassembling and replacing the appropriate layer.

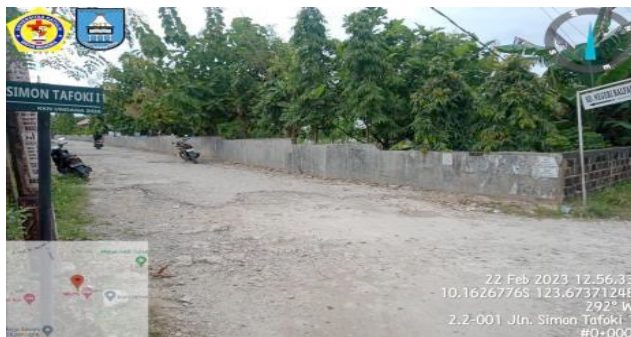
Figure 12. Road Condition Section 1 (Simon Tafoki 1 Street)

For this study, the samples consist of 4 review road segments. Land use types are schools, housing, and boarding houses. Figure 12 illustrates an example of road conditions on section 1. It can be seen that there are potholes and revealing damages on the road section. The roads also do not have sidewalks or road drainage.

Sta		SDI		
From	To	Value	Condition	Recommendation
000+000	00+200	55	Moderate	Routine Maintenance
00+200	00+400	3	Good	Routine Maintenance

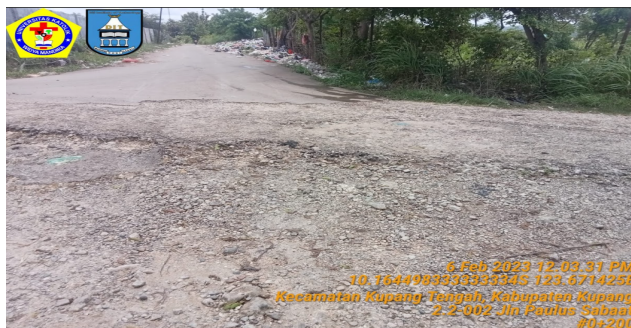
Figure 13. Road Condition Section 2 (Paulus Saba'at Street)

Figure 13 illustrates an example of road conditions on section 2. It can be seen that there is longitudinal damage and edge cracking damage.

Sta		SDI		
From	To	Value	Condition	Recommendation
000+000	00+200	238	Heavy Damage	Reconstruction
00+200	00+211	3	Good	Routine Maintenance

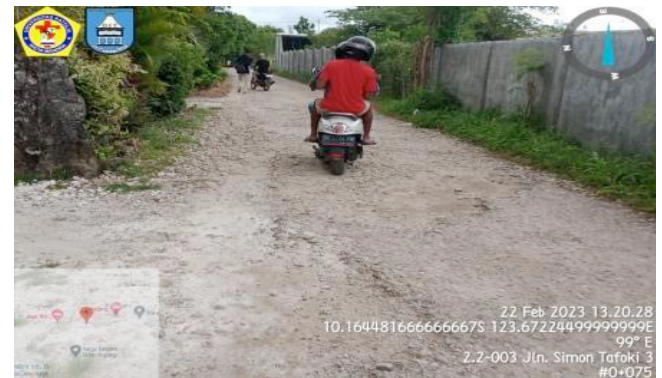
Figure 14. Road Condition Section 3 (Simon Tafoki 3 Street)

Figure 14 illustrates an example of the condition of road section 3. It can be seen that there are potholes and revealing. The roads also do not have sidewalks or road drainage.

Sta		SDI		
From	To	Value	Condition	Recommendation
000+000	00+200	75	Moderate	Routine Maintenance
00+200	00+247	15	Good	Routine Maintenance

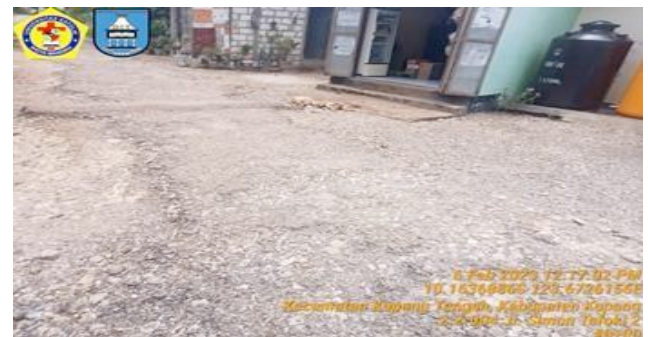
Figure 15. Road Condition Section 4 (Simon Tafoki 2 Street)

Figure 15 illustrates an example of the condition of road section 4. It can be seen that there are potholes and cracking damages. The roads also do not have sidewalks or road drainage.

Sta		SDI		
From	To	Value	Condition	Recommendation
000+000	00+175	15	B	Routine Maintenance

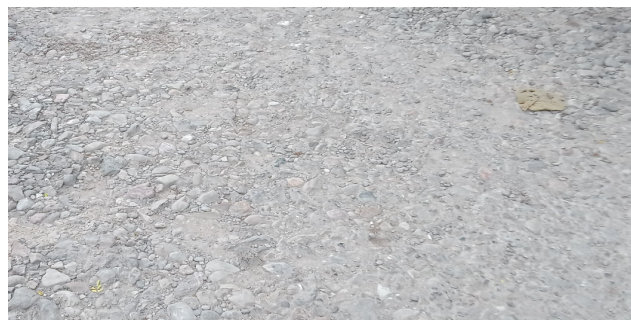
**Figure 16.** Example of Reveling Damage on Location

a. Reveling

Causes: Poor mix of asphalt layer material, weakening of binder and/or rock, Poor compaction, because it is done during the rainy season, and Hydrophilic aggregate (aggregate easily absorbs water).

Treatment: Surface treatment using vocal chips or slurry seals for 39% of reveling damage.

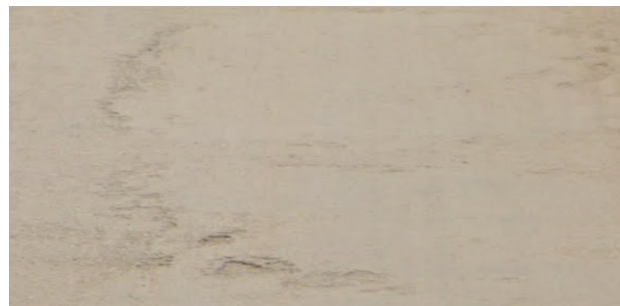
**Figure 17.** Example of Longitudinal Crack Damage on Location

b. Longitudinal Crack

Cause: There is a change in the volume of soil in the subgrade due to vertical movement and subsidence of piled up soil or movement of the embankment slope.

Treatment: Repair or Closure of cracks of 20% of the road segment area.

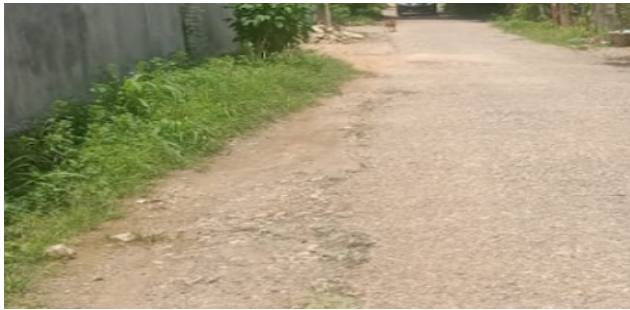
Figure 18. Example of Edge Crack Damage on Location

c. Edge Crack

Causes: Lack of support from the lateral direction (from the road shoulder), Poor drainage, Swelling and shrinkage of the surrounding soil, the shoulder of the road drops against the pavement surface, Weak seal coat, Loss of surface adhesion to the base layer, Heavy traffic concentration on near the edge of the pavement and the existence of large trees near the edge of the pavement.

Treatment: If the shoulder of the road does not support the pavement edge, then it is dismantled and replaced with compacted good material, if the causative factor is water, drainage must be made, surface crack closure/covering and partial patching of 24% of the road segment area must be made.

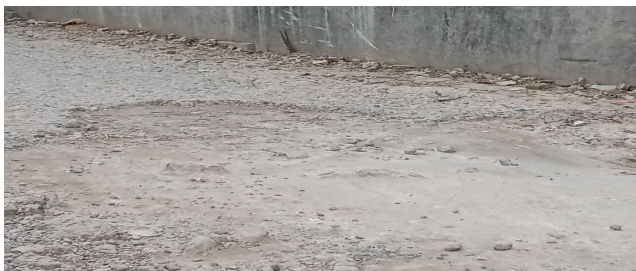
Figure 19. Example of Potholes Damage on Location

d. Potholes

Causes: Poor surface layer material mixture, water ingress into the foundation layer through unrepaired cracks, disintegration of the base layer due to traffic loads and removal of asphalt from the worn layer due to adhering to vehicle tires.

Treatment: Repairs on 17% of the road segment area with patching in all depths and temporary repairs by cleaning and filling the potholes using a special cold asphalt mixture for patching.
